Preliminary Nexus Summary For The ARCO – BP Oil Corporation 3/10/17

Part I – Site Summary Overview – BP Oil Corporation	
Refinery Operational Period	<p>1936 to July 1973</p> <p>The Atlantic Refining Company; Atlantic Richfield Company (“ARCO”); Standard Oil Company of Ohio (“Sohio”); and BP Oil Corporation¹</p>

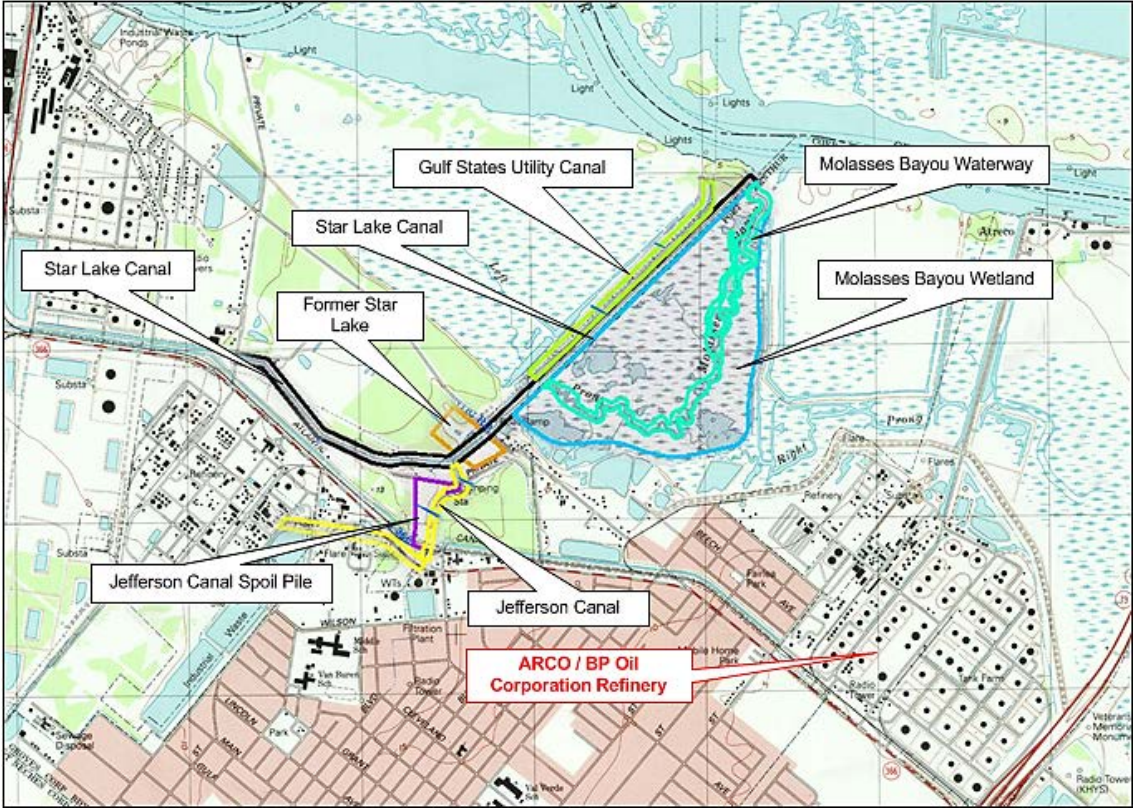
<p>Figure 1. The topographic map depicts the former BP Refinery in relation to the seven highlighted areas of interest (“AOIs”) in the Star Lake Superfund Site.² Source: USGS, 1993</p>
Nexus Summary	<p>BP Refinery discharges containing CERCLA-listed hazardous substances, contributed to contamination present in the Star Lake Canal Superfund Site and the Molasses Bayou Waterway and Molasses Bayou Wetlands Areas of Interest (“AOI”) in particular.</p>

² The seven AOIs, as depicted in Figure 1, include Jefferson Canal, Jefferson Canal Spoil Pile, Former Star Lake, Star Lake Canal, Gulf State Utility Canal, Molasses Bayou Waterway, and Molasses Bayou Wetland (Conestoga-Rovers & Associates and Cardno ENTRIX, *Final Tier 2 Remedial Investigation Report*, August 2011, pp. 12–14; USEPA, Region 6, *Record of Decision: Star Lake Canal Superfund Site*, September 2013, pp. 1–3).
